December 13, 2016

**Re: Crebilly Farm – Physical Description of Structures**

Crebilly Farm - Physical Description of Structures  
 Attachment 1  
 Site Plans  
 December 13, 2016

Crebilly Farm - Physical Description of Structures  
 Attachment 2  
 Existing Structures Inventory  
 December 13, 2016

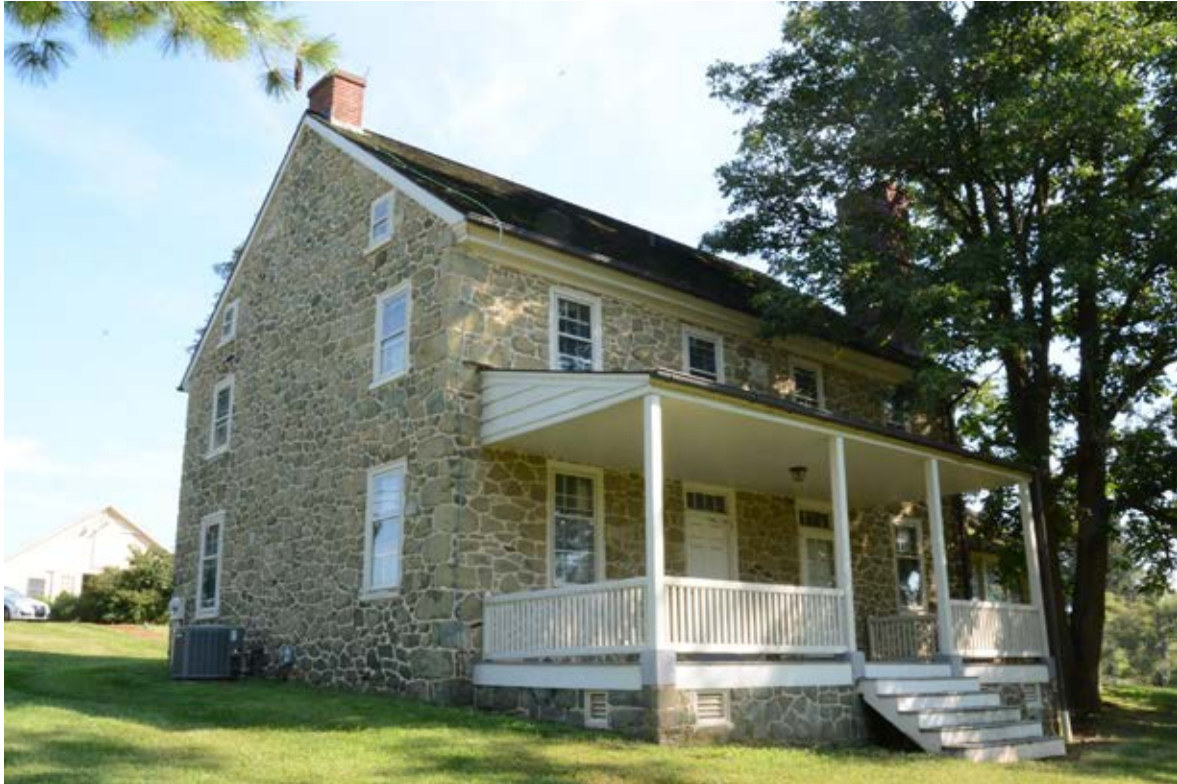
Photo 3

The **Joshua and Lydia Hunt farmhouse** (1129 New Road) is a two-story, four-bay serpentine stone house constructed in 1805 (date stone) and reflects the Federal style (Photo 3). The building includes a sunroom off its east end constructed in 1977. The main block has wood shingles on its end-gabled roof and two brick chimneys: one centered on the west end and one in the southeast corner. The rubble serpentine stone walls feature symmetrical fenestration and a date stone on the south elevation. Windows are twentieth century replacement units. Two original paneled doors on the south elevation open below four-light transoms onto the front porch, which extends along the western three-quarters of the elevation. The porch has a shed roof supported by four thin square posts connected by a low railing; the porch has a stone foundation. The west end wall features two ranks of windows. Fenestration on the north elevation displays the least symmetry; the four-bay elevation includes a centered door opening below a small gabled porch and a landing window. The sunroom is a one-story gabled section with serpentine corners and large plate glass windows.

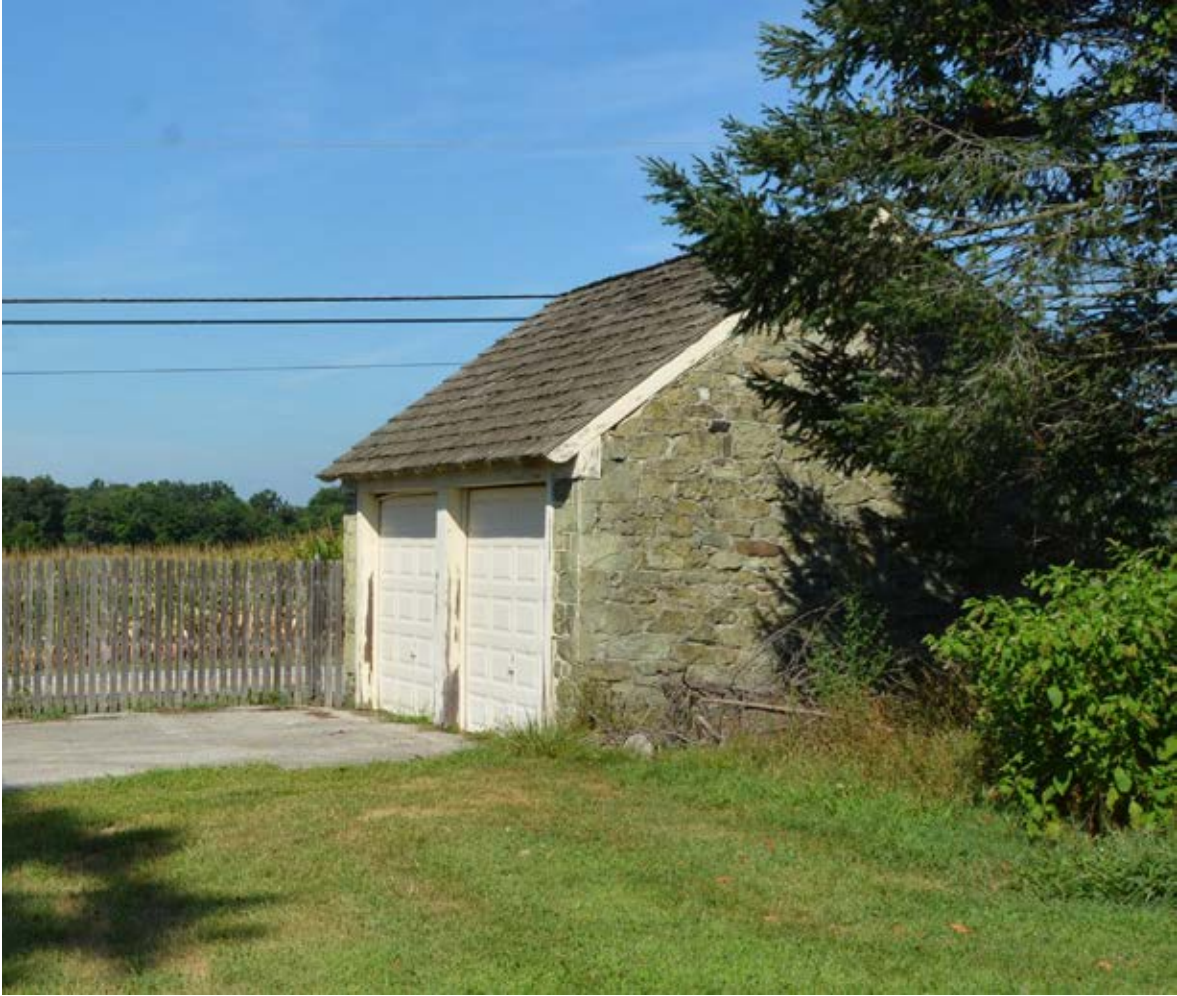
Photo 4

The **serpentine garage** is located northwest of the 1805 farmhouse and just off New Road (Photo 4). Breou's 1883 Atlas shows a blacksmith shop in this location (Figure 1). The one-story, two-bay building has a wood shingled roof with exposed rafter tails. The end walls and the north side wall were built with serpentine stone. The south elevation features two overhead garage doors. Historic 3/6 windows are located on the north and west elevations. The garage has a stone foundation.

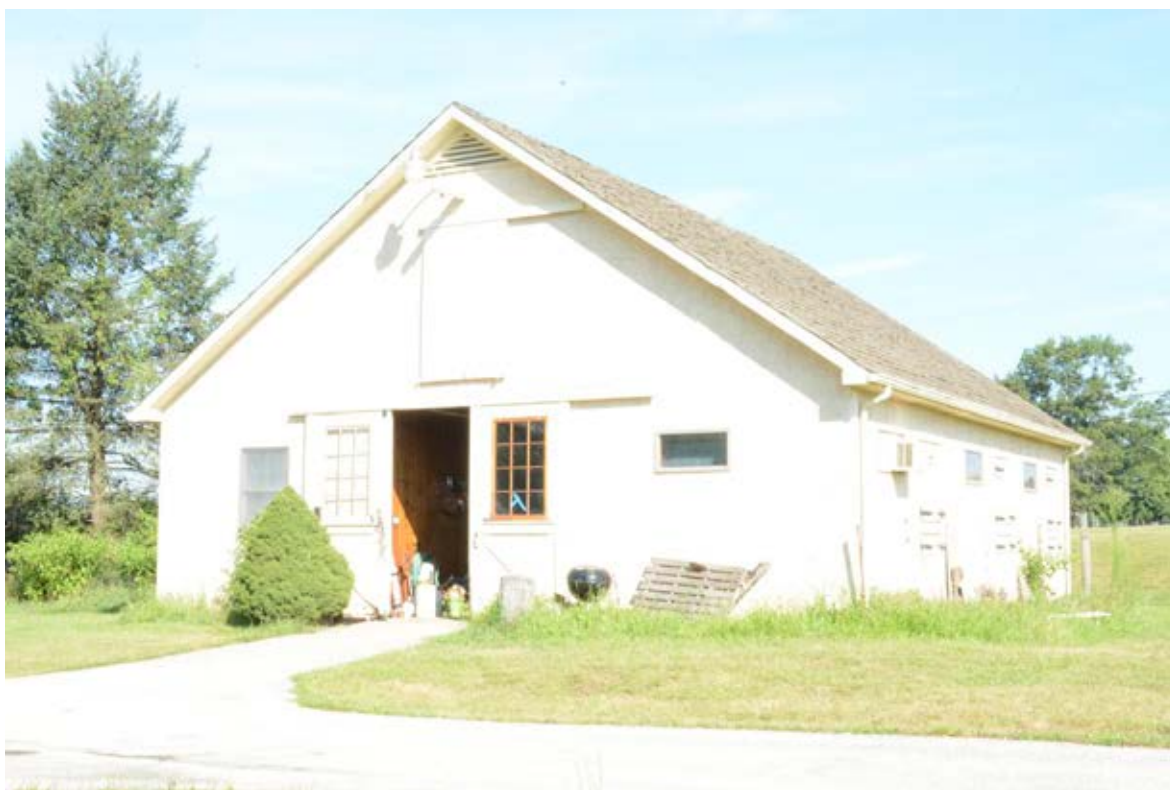
Photo 5

The **former stable** is a frame building north of the 1805 farmhouse and dates to the 1970s (Photo 5). The one-story building has a front end gabled roof facing south to the farmhouse. The roof is clad with wood shingles, and the frame walls are stuccoed. The building has sliding doors on its main elevation; its side walls feature Dutch doors alternating with small horizontal windows.

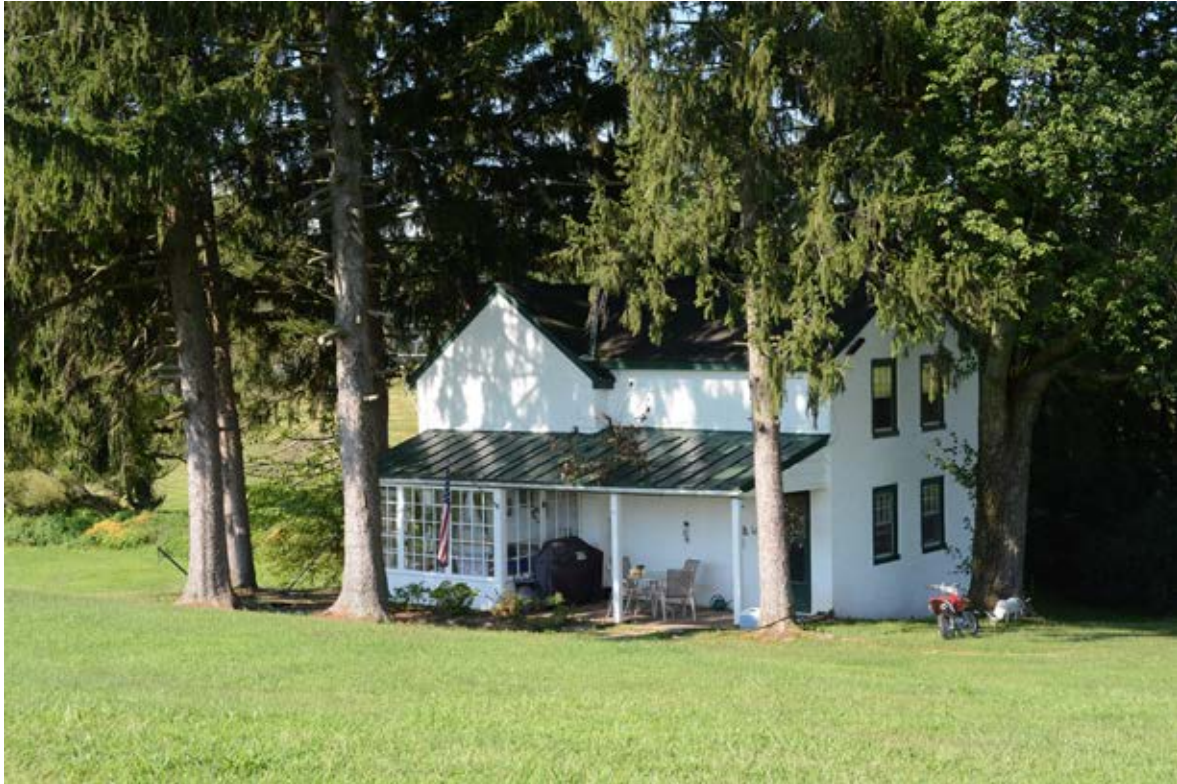
Photo 6

The **springhouse residence** (1125 New Road) is a vernacular three-part building located east of the 1805 house (Photo 6). Its main block is a two-story, three-bay stone section built over a spring. The main block has asphalt shingles on its end-gabled roof and stuccoed walls. The south elevation has a pent roof but no door in the usual location. A frame two-story addition on the west end includes large areas of windows on the second floor and a door on grade facing the 1805 farmhouse. Off the rear of the main block is a two-story wing with an unusual design. It has the same cladding materials as the main block. Its east elevation has only one wall opening: a door near the northeast corner that opens onto a porch extending along the entire east elevation of the building; the portion of the porch on the east end of the main block is enclosed. The rear wing has historic multi-light windows and a wall dormer on its west elevation. The building has a stone foundation.

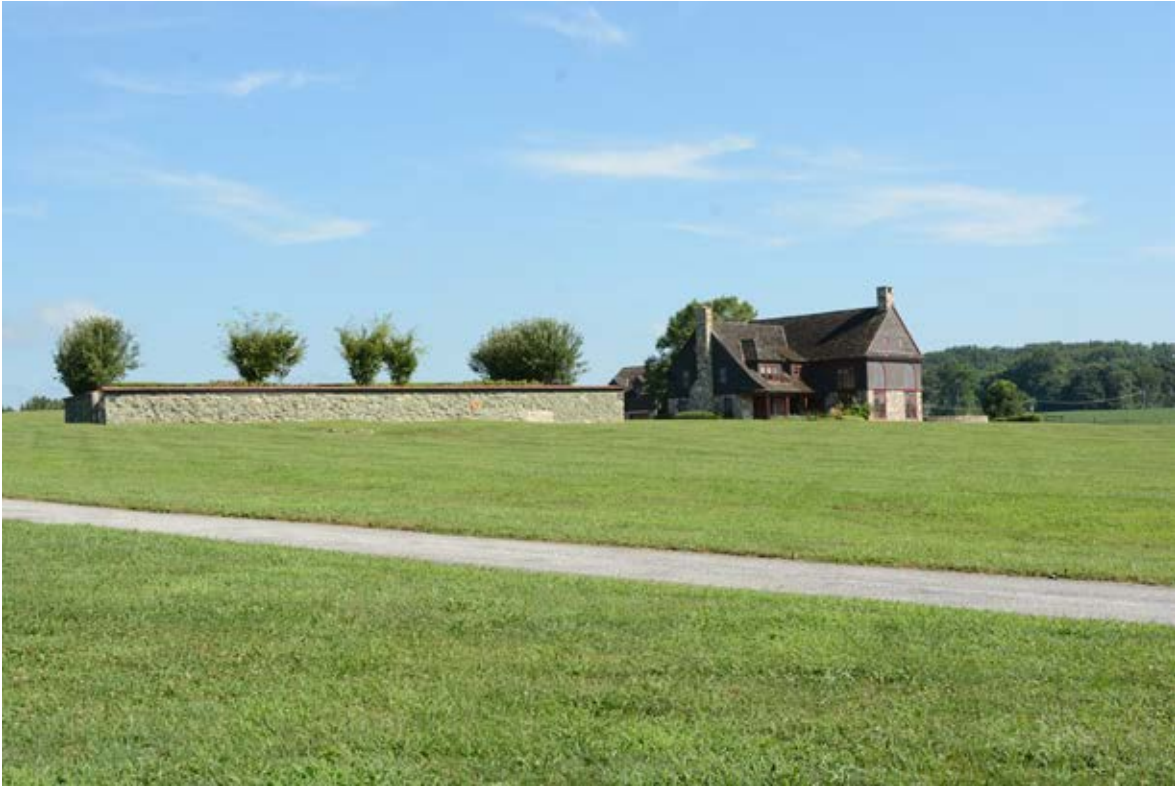
Photo 8

**The Robinson house**, located at **1119 New Street**, was constructed in 1998 (Photo 8). It is located north of the Hunt farmhouse. The two-story residence has an overall L-shape with some Colonial Revival features such as cornice returns, large stone chimneys, arched headed windows, and wall dormers. The south part of the house has gabled projections on either side, flanked by dormers. The ell section includes an attached garage section.

The **barn yard wall** is the remnant of a stone barn that burned in 1996 (Photo 8). The east, south, and west spans of the wall survive. The walls rise to a height of approximately three feet and have an angled roof clad with wood shingles. Fencing defines the north wall, and a frame gate is located at the southwest corner.

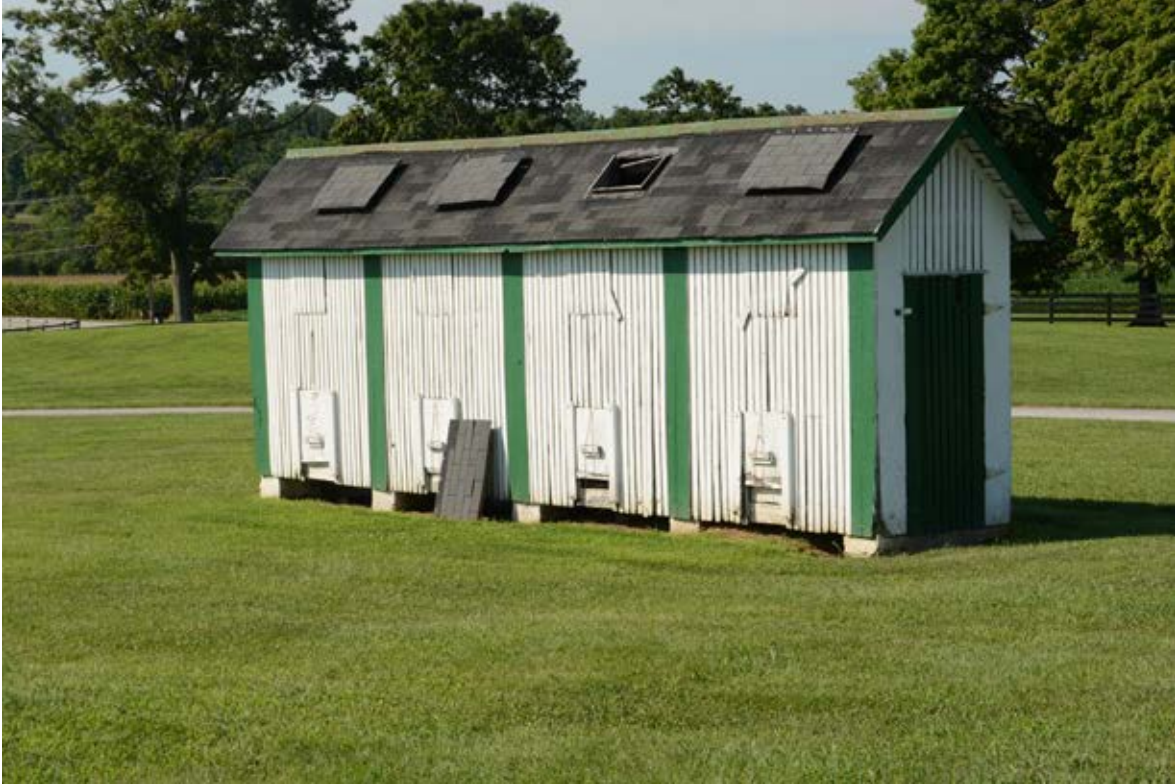
Photo 9

The **corncrib** is a small agricultural outbuilding located west of the Robinson house (Photo 9). The corncrib is a narrow rectangular building with the gable walls facing north and south. The gabled roof is clad with asphalt shingles and features four hinged lids that were used to fill the interior with corn. The walls are built of vertical slats and also feature lids for loading corn. Narrow batten doors are located on the end walls. The corncrib stands on concrete piers.

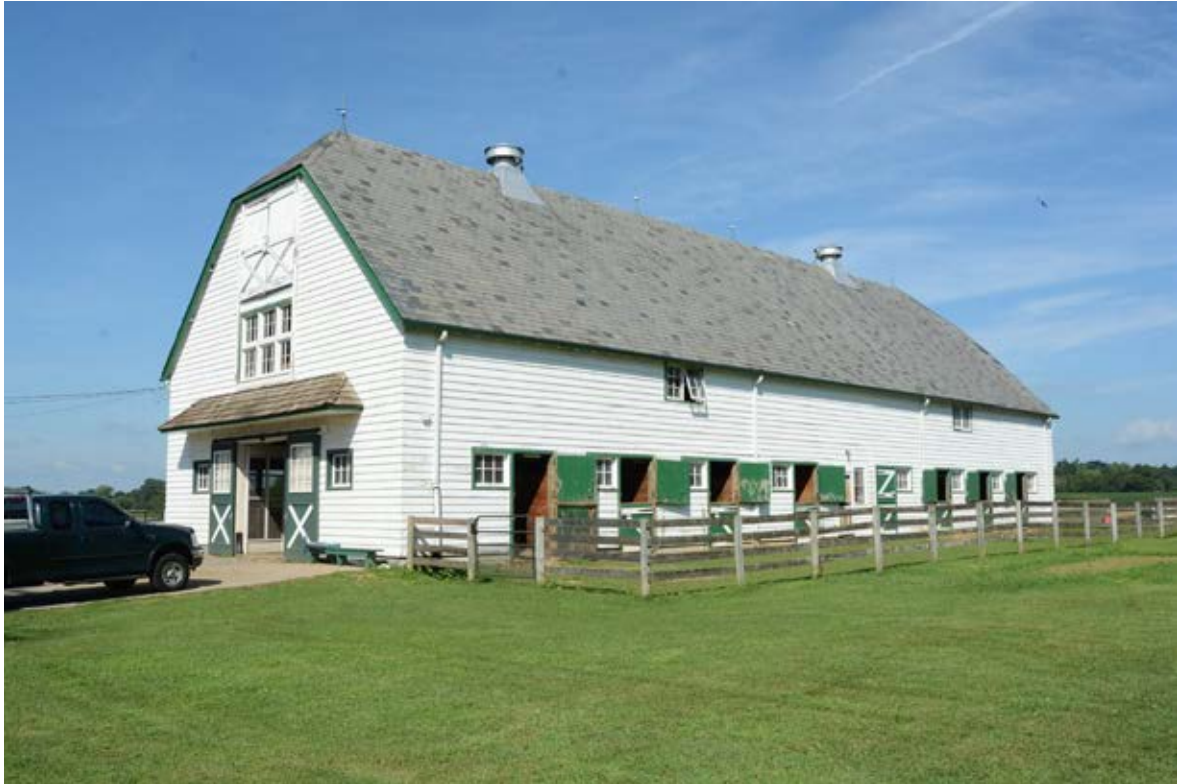
Photo 11

The **horse barn** is one of the largest buildings on the entire property and anchors the equine cluster, with several other buildings oriented around it (Photo 11). The building has a front end gabled orientation, with its main entrance on the south end. The roof has clipped gables, two ridge ventilators, and slate shingles. The frame walls are clad with clapboards. The south end features two doors below the clipped gable over a tripartite window on the upper level and two sliding doors below a pent roof on the first floor. The side walls feature small six-light hopper windows on the upper level and multiple Dutch doors interspersed among six-light hopper windows on the first floor.

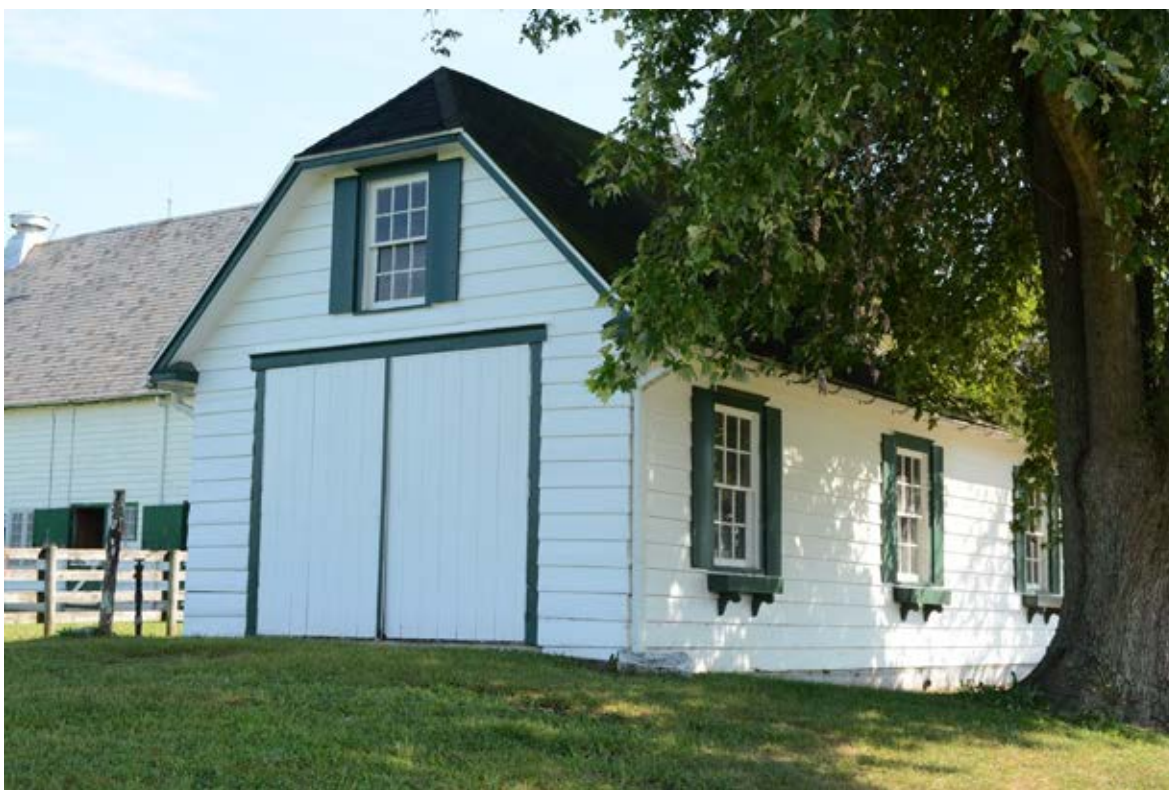
Photo 12

The **carriage house** is a one-story frame building southwest of the horse barn (Photo 12). It has a clipped gable roof clad with asphalt shingles. The walls are clapboard. Windows are 6/6 double hung sash units flanked by vertical boards that mimic shutters. A double batten door on the west end provides access by vehicles, and a human-scaled door is located on the east end.

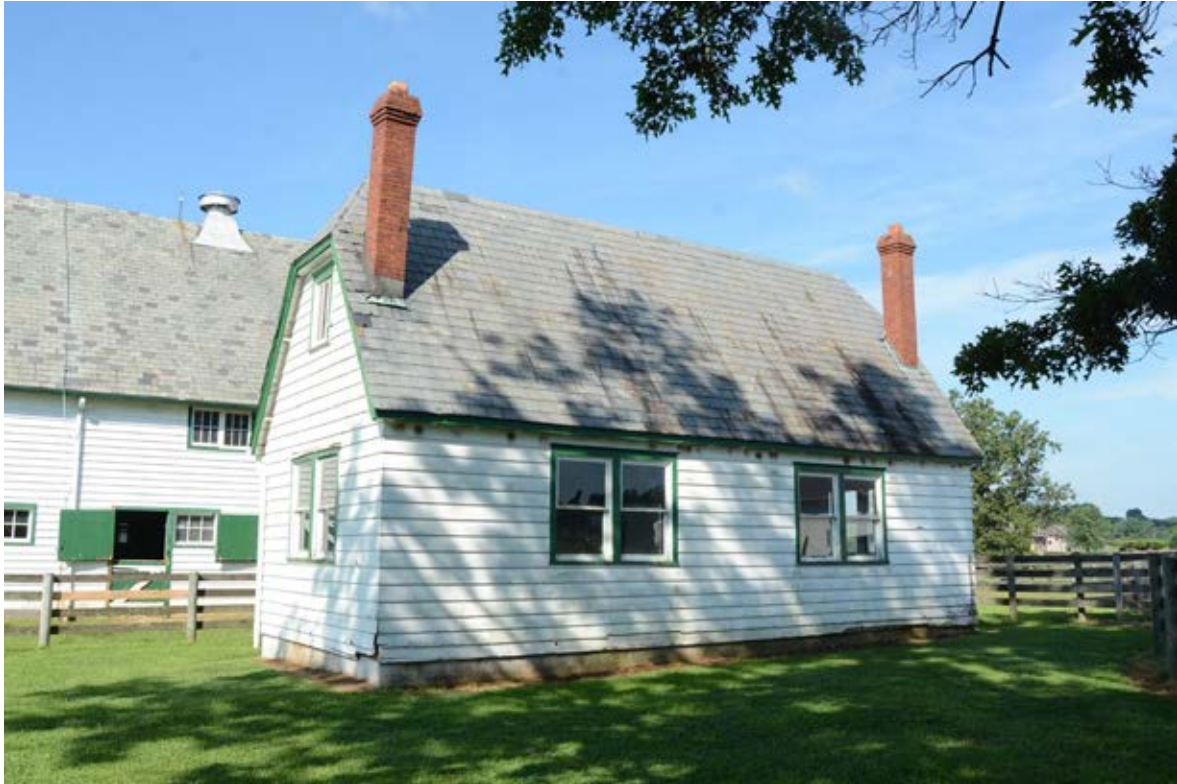
Photo 13

The **blacksmith shop** is a small building east of the horse barn (Photo 13). Like the horse barn, it has a clipped gable roof clad with slate shingles. Two small square brick chimneys are located on the east slope of the roof. The clapboard walls feature 1/1 double hung sash windows, most of which are paired, and a door on the north end. The building has a concrete foundation.

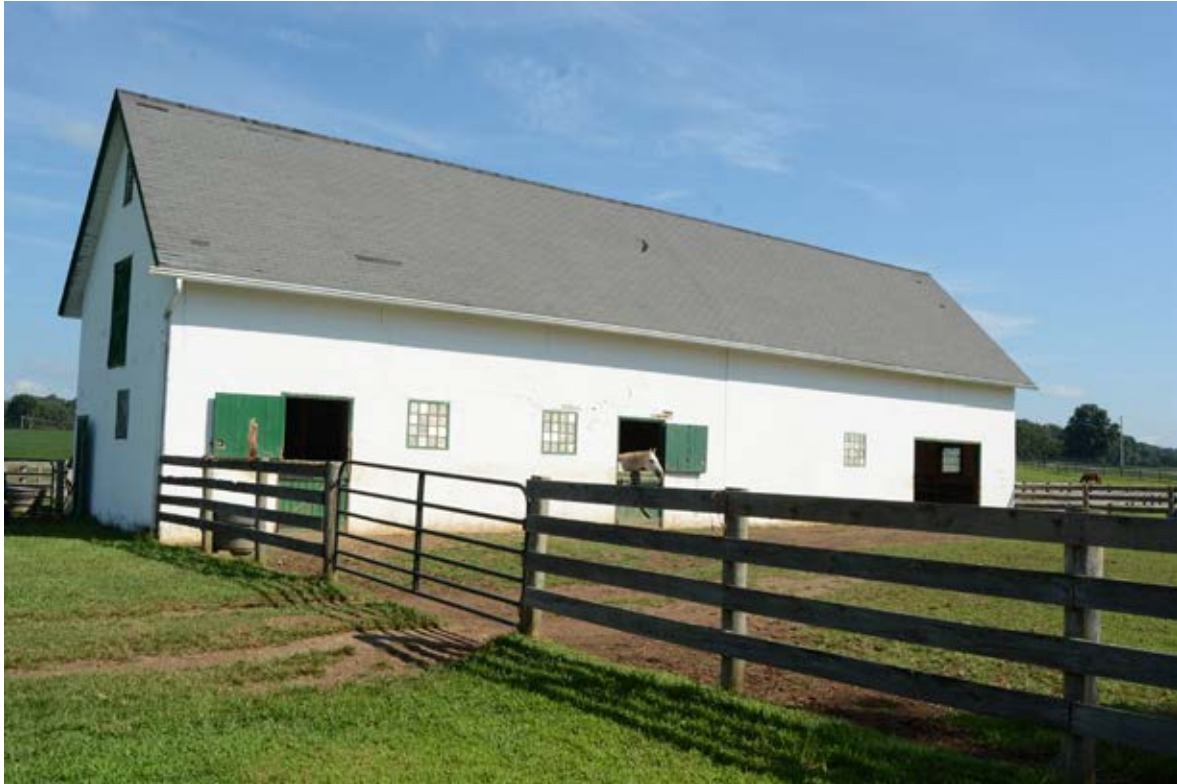
Photo 14

The **stud barn** is located northeast of and perpendicular to the horse barn (Photo 14). Its end-gabled roof is clad with asphalt shingles. The south (main) elevation has two Dutch doors flanking small glass block windows lighting the interior stalls and a large doorway near the southeast corner for equipment. The end walls feature second floor loading doors.

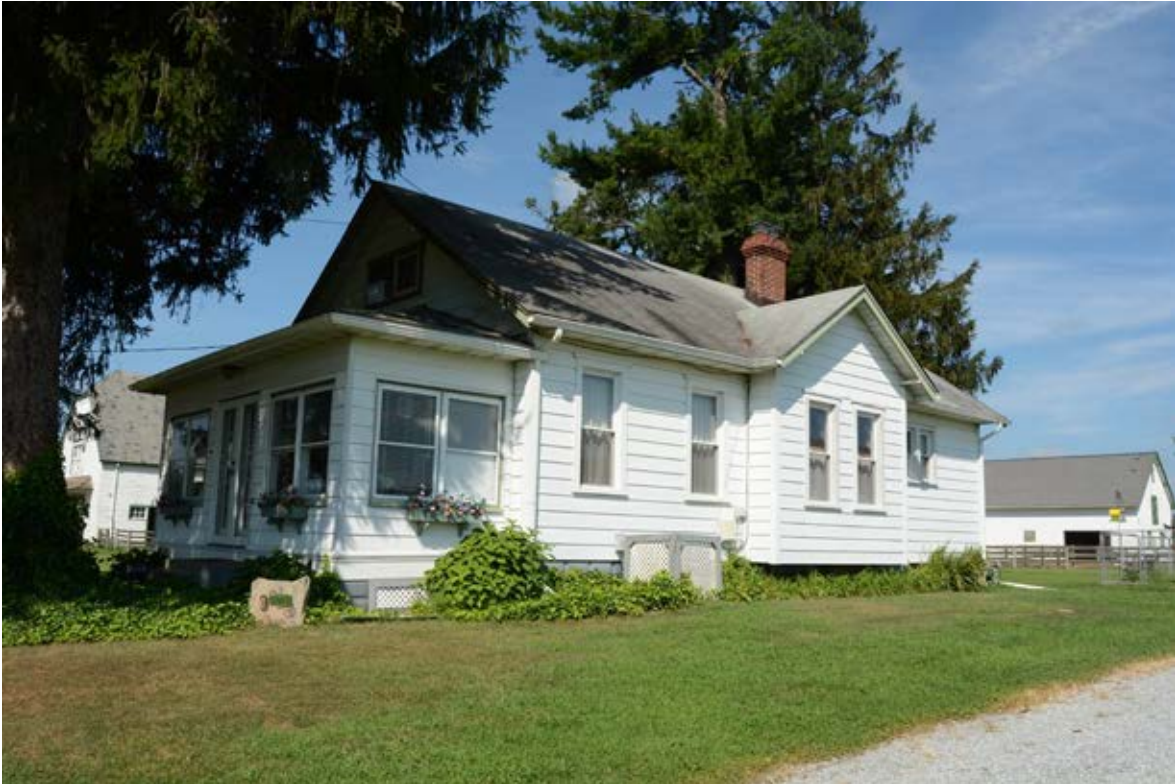
Photo 15

The **caretaker's house** (1127 New Street) is a bungalow presumably built for the farm or equine center manager (Photo 15). It consists of a main block with an enclosed front porch on the south elevation. The building's architectural features are similar to Sears-type kit houses popular in the early twentieth century. It

has asphalt shingles on the roof and aluminum-clad walls. A gabled bay on the east elevation projects below the brick chimney. Windows are primarily 1/1 double hung sash units. The building has a rusticated concrete block foundation.

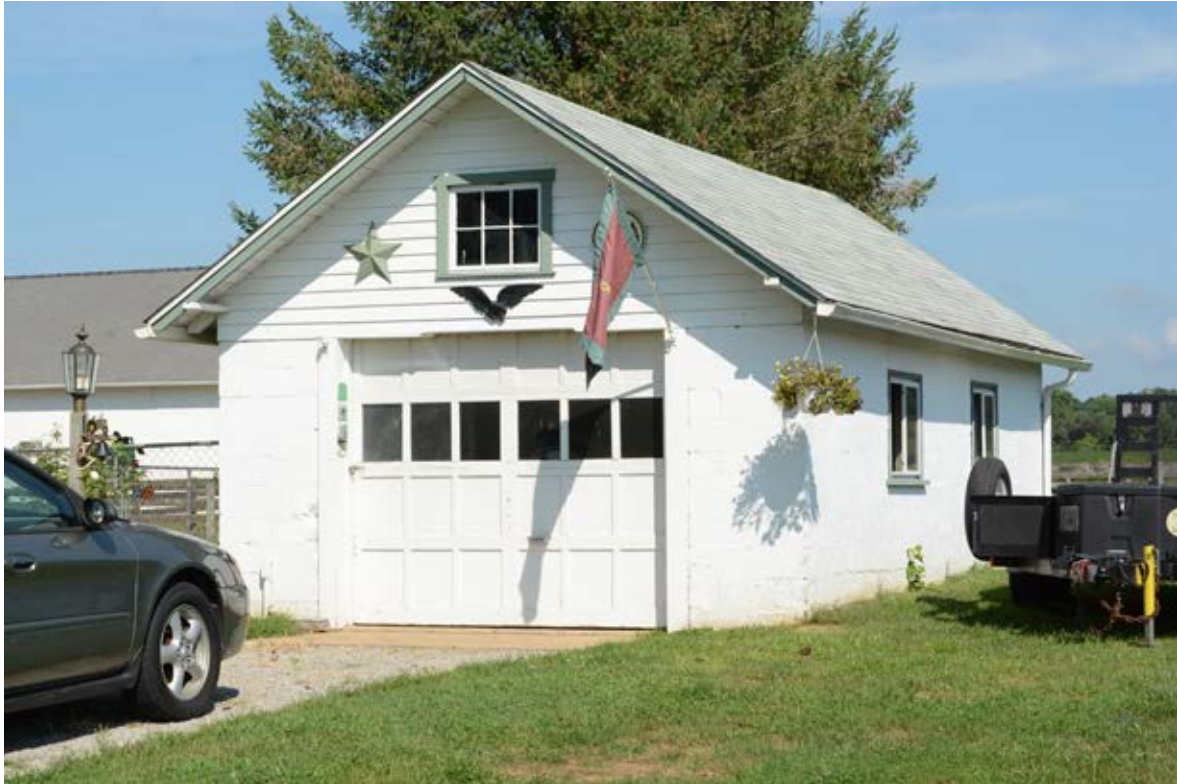
Photo 16

The **block garage** is located northeast of the bungalow (Photo 16). The front end gabled building has asphalt shingles on the roof and block walls. The wall area above the eave line is clad with aluminum siding. Wall openings include an overhead garage door on the south elevation and six-light windows.

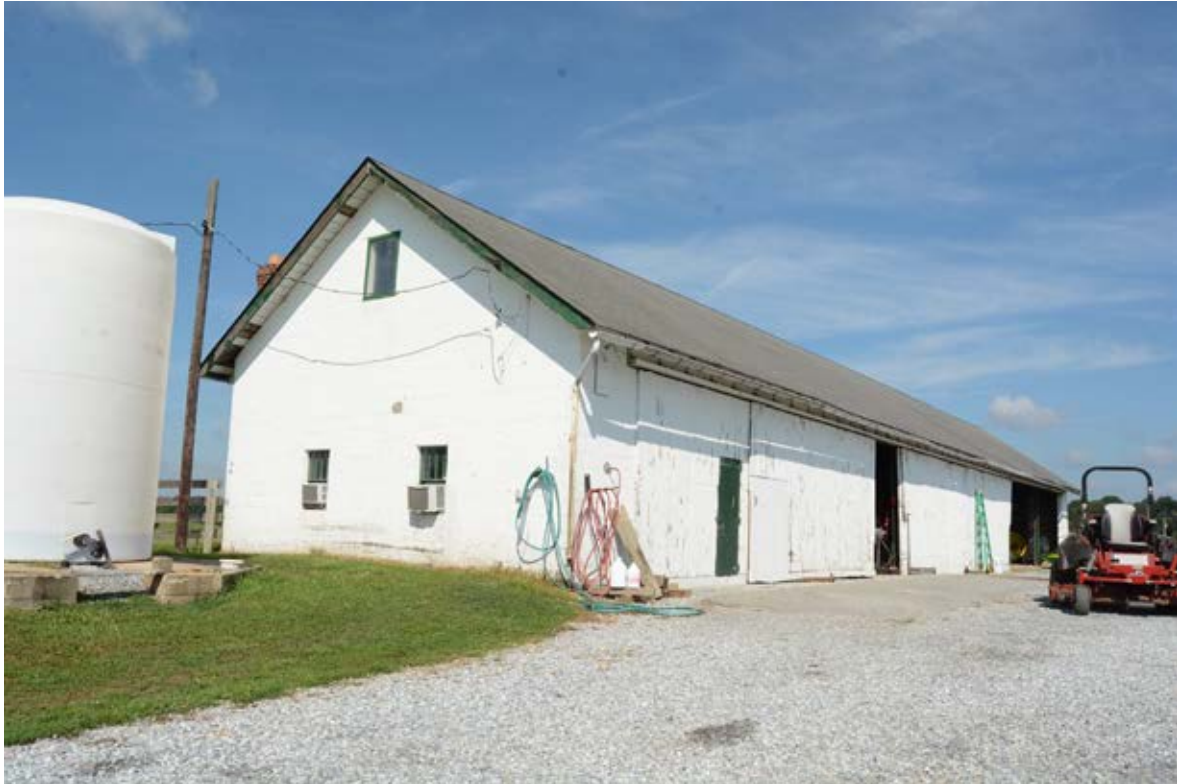
Photo 18

The **farm shop** is located north of Barn #2 (Photo 18). The long rectangular building has asphalt shingles on its gabled roof. The walls are block. The main (east) elevation features large sliding doors with wicket (inset) doors occupying a large portion of the wall surface. The end walls feature small, multi-light windows. The shop has a block foundation.

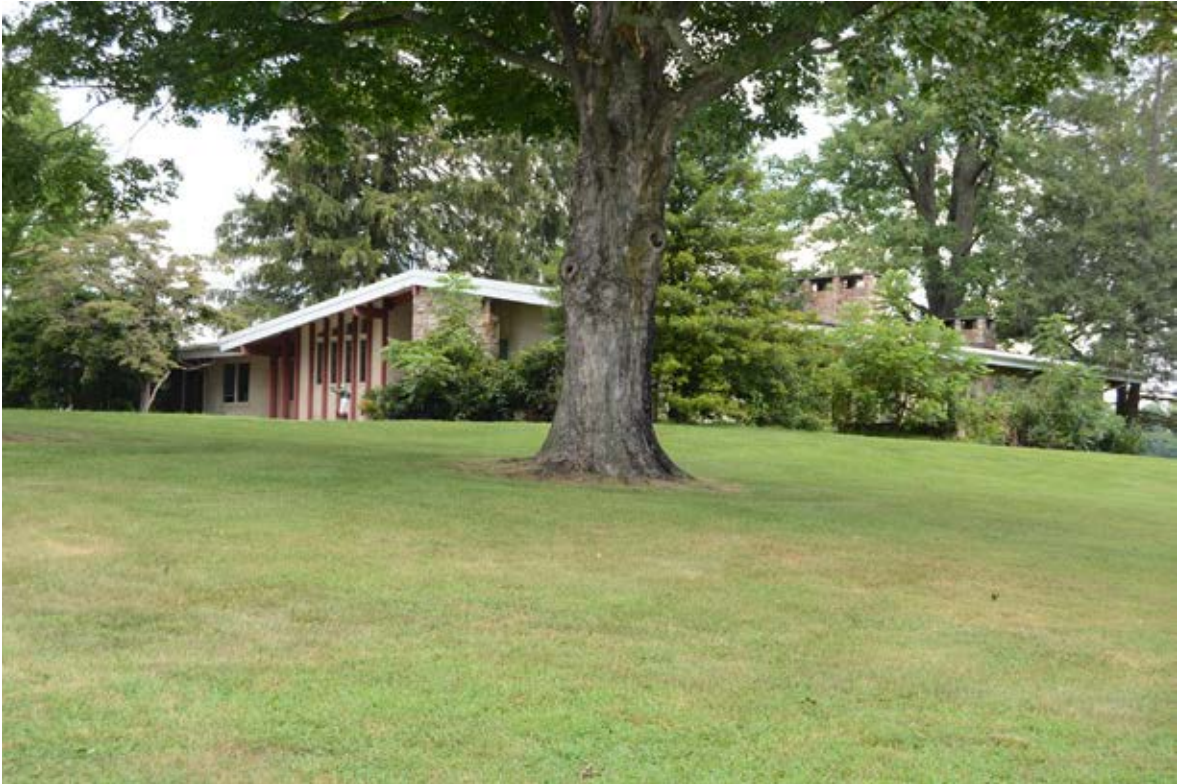
Photo 20

The **modern house at 501 West Street Road** is a modern L-shaped house on the east side of the property drive (Photo 20). It was constructed in 1959-60 to replace an earlier Eli Hunt farmhouse in the same location. The house is a one-story building with a low-pitched roof and large stone chimneys. The walls include areas of stone veneer, areas of stucco, and glazed areas. The north wing of the house extends to encompass an attached garage.

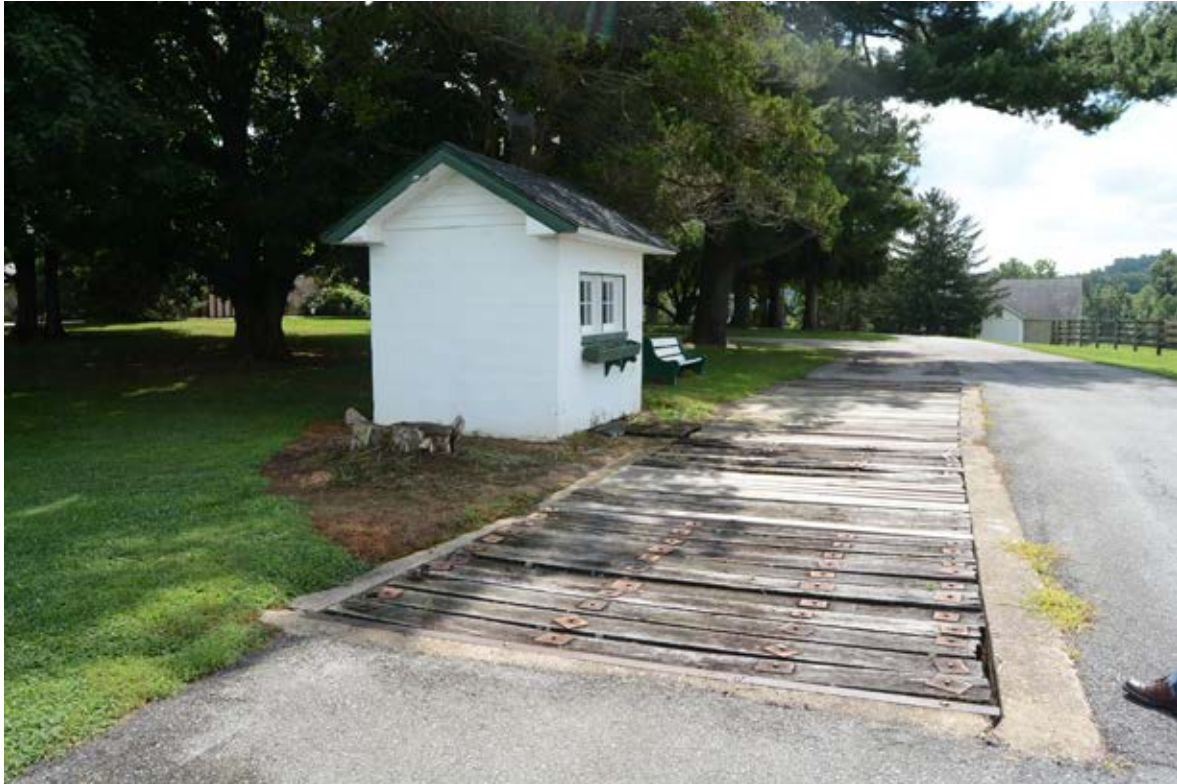
Photo 21

The **scale house** is a small building located northeast of the house at 501 West Street Road (Photo 21). The one-story building has a gabled roof clad with asphalt shingles and features an equestrian-themed weathervane. The frame walls are stuccoed. It is accessed by a narrow door on the south end. On the west elevation, a paired window faces onto the scales where the trailer would be weighed. Railroad ties are used to define the location west of the building where the trailer would be parked to be weighed.

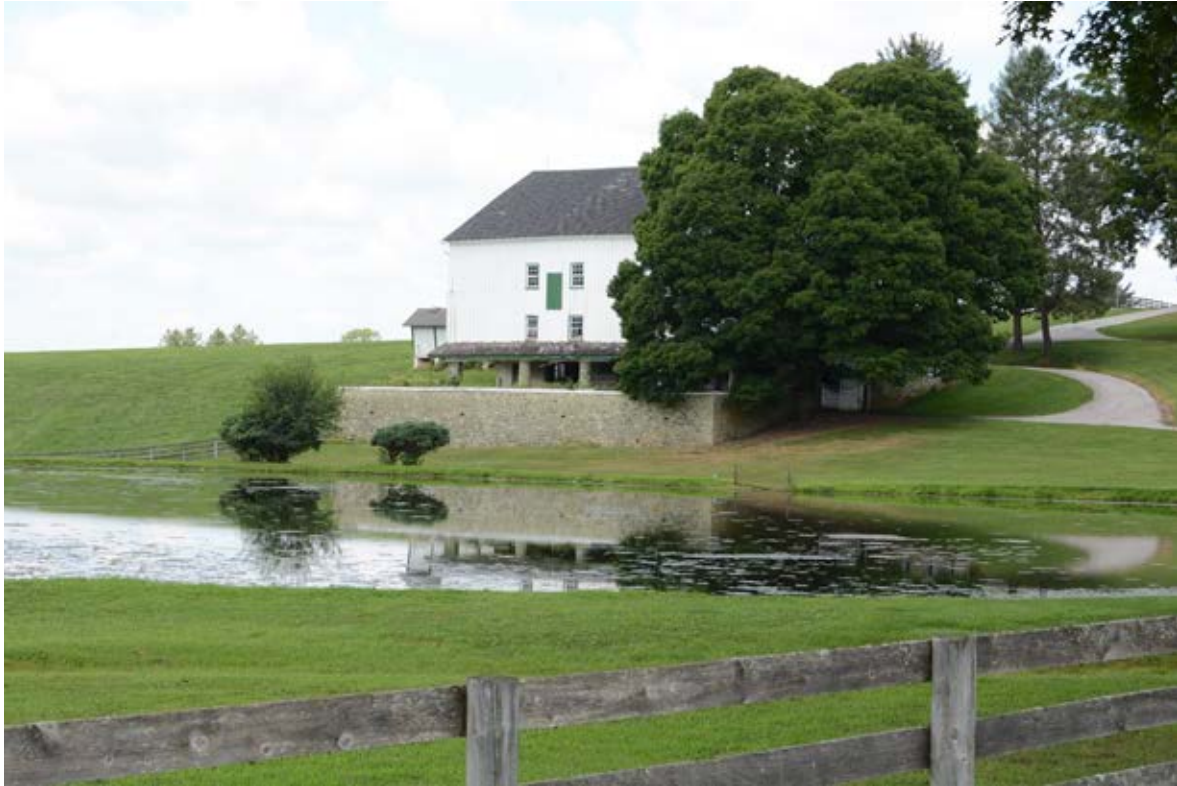
Photo 22

**Barn #1** is a serpentine multi-additive building located southwest of the property drive (Photo 22). It is an example of the "Chester County stone posted forebay double decker barn," according to the typology established by Robert Ensminger (Ensminger 2003: 144). The barn consists of a double decker core with a two-part strawshed off its east end and a barn yard wall to the south. The core has an end-gabled roof clad with asphalt shingles. The north and west walls were built with serpentine stone, and the east and south walls are clad with board and batten. The ramp on the north side is a gabled element with board and batten walls, extending from the uppermost interior level over the passageway to a ramp with stone wing walls. The passageway has been sealed with stone, accessed by an arched headed door to the east and a larger double door to the west. The south elevation features a typical double decker door and window assembly, with a centered winnowing door on the upper level and 6/6 windows on the two upper levels. The window and doors are located on the extended forebay, which is supported by square and conical stone pillars. The strawshed on the east end of the barn core was constructed in two campaigns. It has a shed roof, a serpentine stone east end wall, and frame side walls clad with board and batten. Each elevation varies in appearance. The east elevation features four six-light hopper windows. The north elevation features a batten

sliding door accessing the upper interior level of the section, while the south elevation features an open bay accessing the lower interior level.

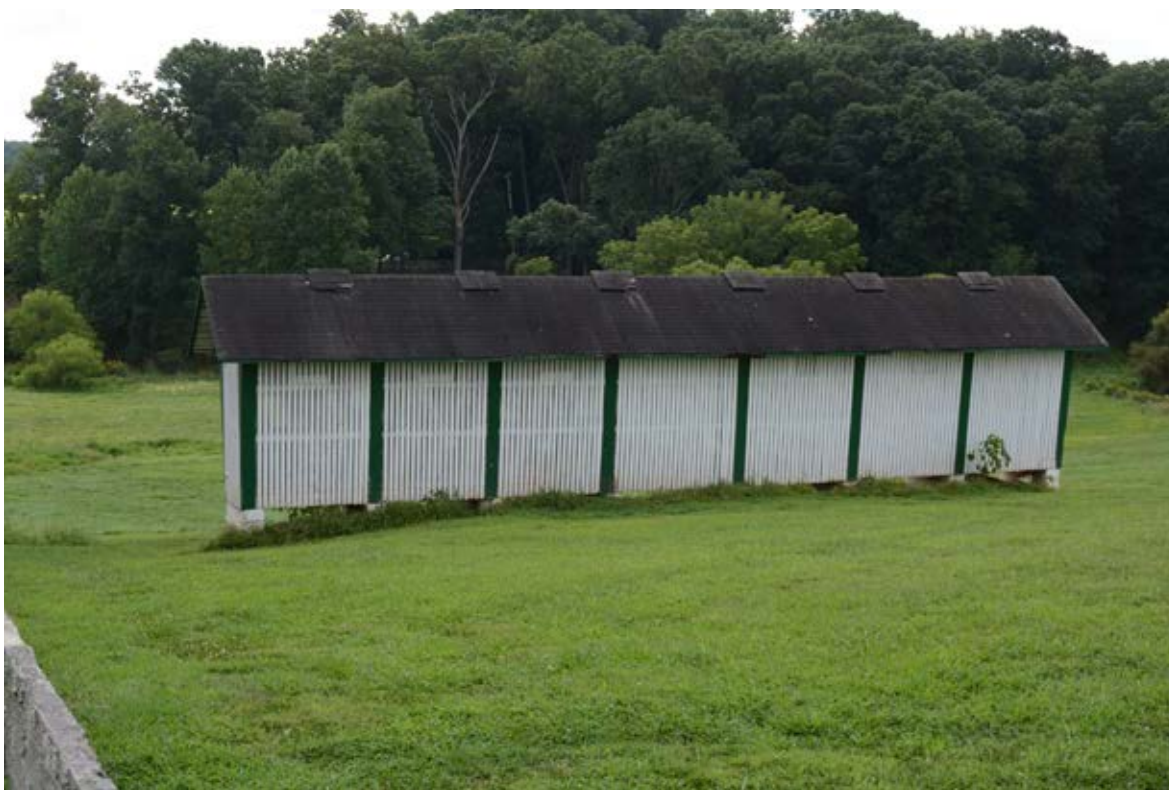
Photo 23

The **corncrib** is located west of Barn #1 (Photo 23). It is an example of the “Connecticut” corncrib, a narrow building with angled sides. The gabled roof is clad with asphalt shingles and features six lids on the ridge. The walls are made of vertical slats with doors on the ends. The corncrib stands on stuccoed posts.

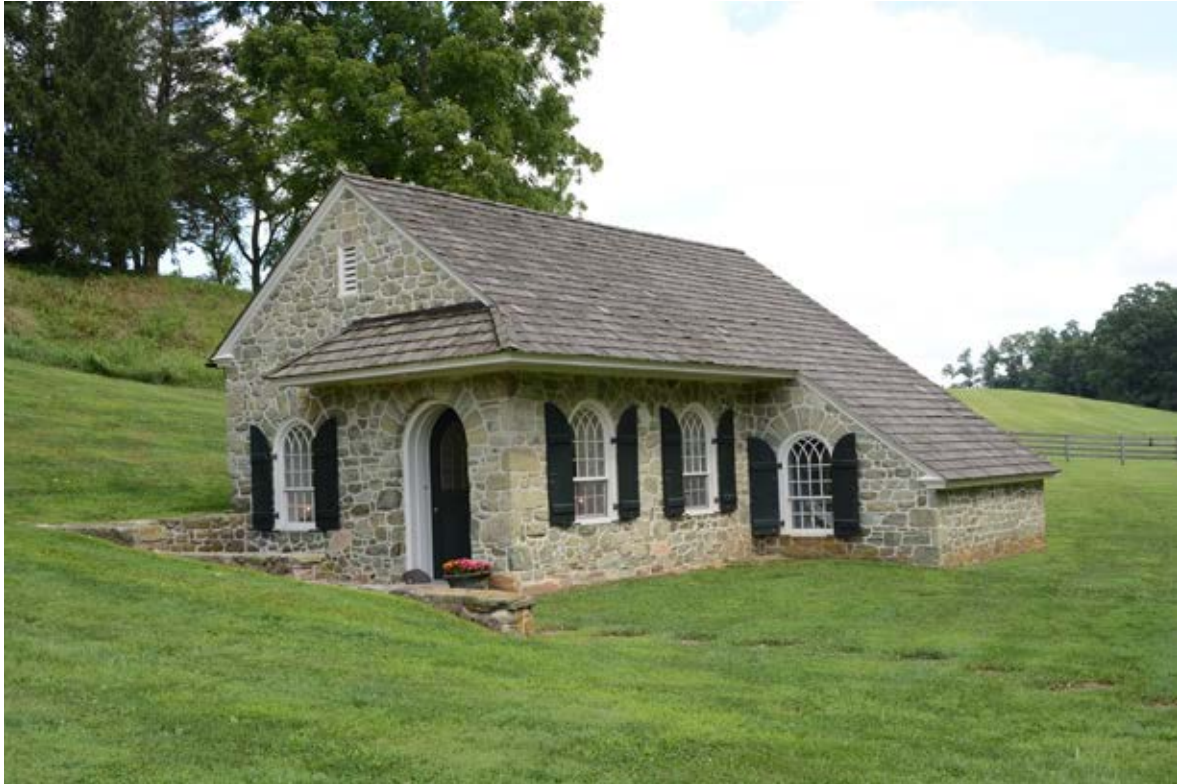
Photo 24

The **former springhouse** is a small serpentine stone building located southeast of the house at 501 West Street Road (Photo 24). It was constructed in 2000 as a chapel on the ruins of a former springhouse. The building has an L-shape. Its roof is clad with wood shingles and features a half-cornice return on the main elevation. The stone walls include arched-headed windows with intersecting tracery and batten shutters. The door is also an arched headed unit with inset lights.

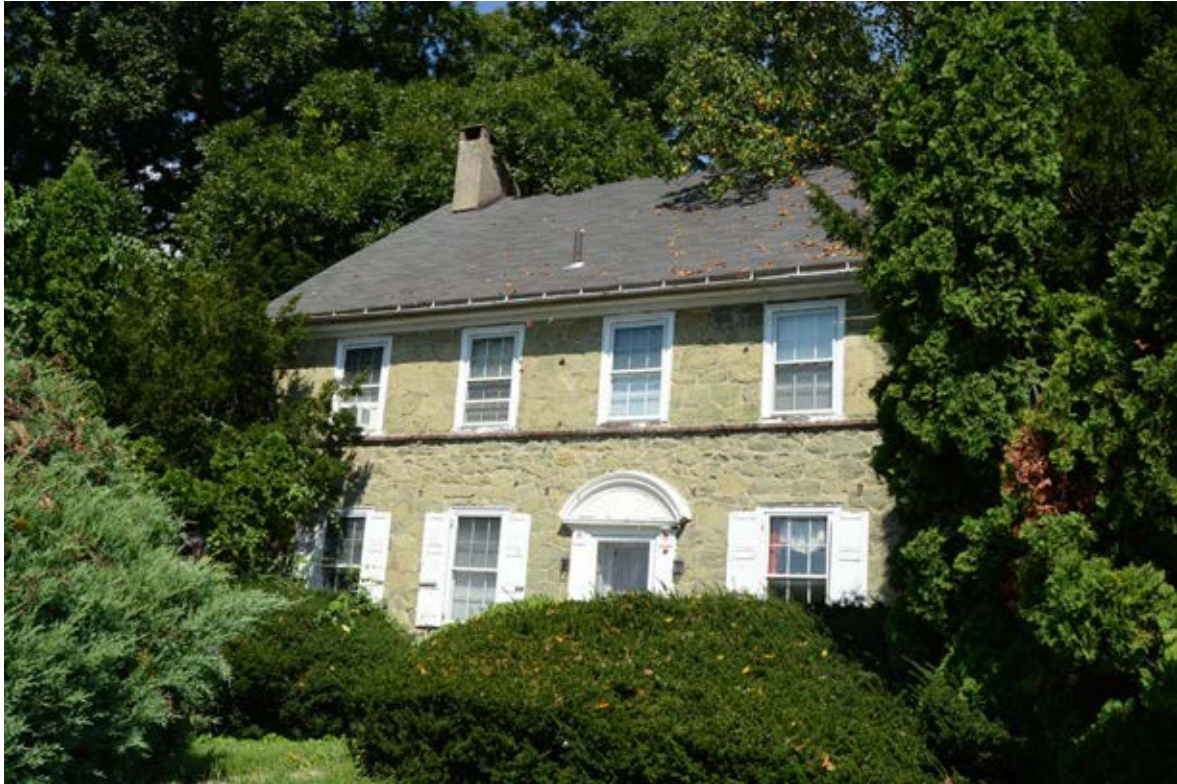
Photo 25

The **Darlington Tavern** is a two-part serpentine stone building consisting of a two-story Federal main block with a one-story rear wing (Photo 25). Historically a tavern, it is now a residence. It has been determined eligible for the National Register of Historic Places (NRHP) (September 9, 2015; Key #67408). The main block is oriented to Street Road; the rear section is oriented parallel to Route 202. The main block is the two-story, five-bay Federal style house measuring approximately 30 feet by 18 feet. It has an end-gabled roof clad with asphalt shingles. At each end of the ridge is a large rectangular stucco over brick chimney. The molded cornice includes small returns on the end walls.

The walls of the main block are serpentine stone with excellent masonry. Features of the walls include the 1823 date stone on the east elevation and the incised markings on the south elevation including a likeness of

a dog named Lincoln and a bust of Henry Clay. A brick flashing course and lower grade stone work between the first and second floor windows indicate that the building was constructed with a pent roof. Fenestration is symmetrical, with five bays of wall openings aligned vertically and horizontally. Windows, almost all original, are 6/6 (except for the four-light attic windows); the first floor windows have three-paneled shutters with their original hardware. The door is located in the center bay; it has two large glass panes over two large panels and a paneled architrave. Over the door is a segmental-arched wooden fanlight supported by reeded columns with floral corner blocks. The foundation of the house is serpentine stone.

The one-story, two-bay rear wing is located slightly east of the center of the main block and may date to the eighteenth century. The roof is gabled and clad with asphalt shingles. A large brick chimney is located on the north end of the ridge. The walls are serpentine stone. The east and west walls originally had doors in the south bays and 6/6 windows in the north bays; the door facing Route 202 has been sealed. The door on the west elevation is an eight-panel Federal style element with matching paneling in its architrave. The north end has a four-light window lighting the loft and a flashing course which indicates the location of a roof over the now-removed bake oven.

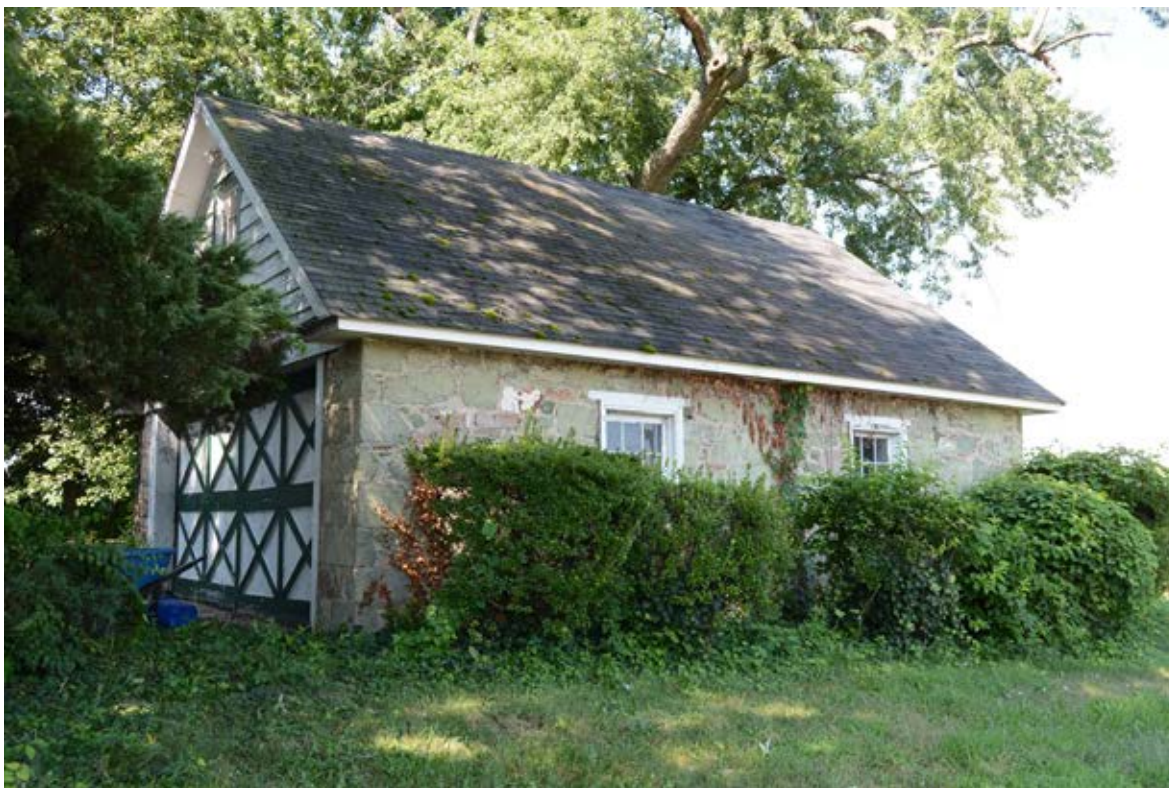
Photo 26

The **garage** is located north of the tavern (Photo 26). It appears to have replaced an earlier L-shaped building shown in the Mueller Atlas of 1912 (Figure 2). The garage is a 14-foot by 14-foot front-gabled building facing south towards the tavern. It has an asphalt-shingled roof, with the ridge running parallel to Wilmington Pike. The side walls and north end wall are stone. The south wall has clapboards with a 6 over 6 window over two large Colonial Revival sliding doors. The floor of the garage is cement.
