December 13, 2016

**Re: Crebilly Farm – Physical Description of Structures**

Crebilly Farm - Physical Description of Structures  
 Attachment 1  
 Site Plans  
 December 13, 2016

Crebilly Farm - Physical Description of Structures  
 Attachment 2  
 Existing Structures Inventory  
 December 13, 2016

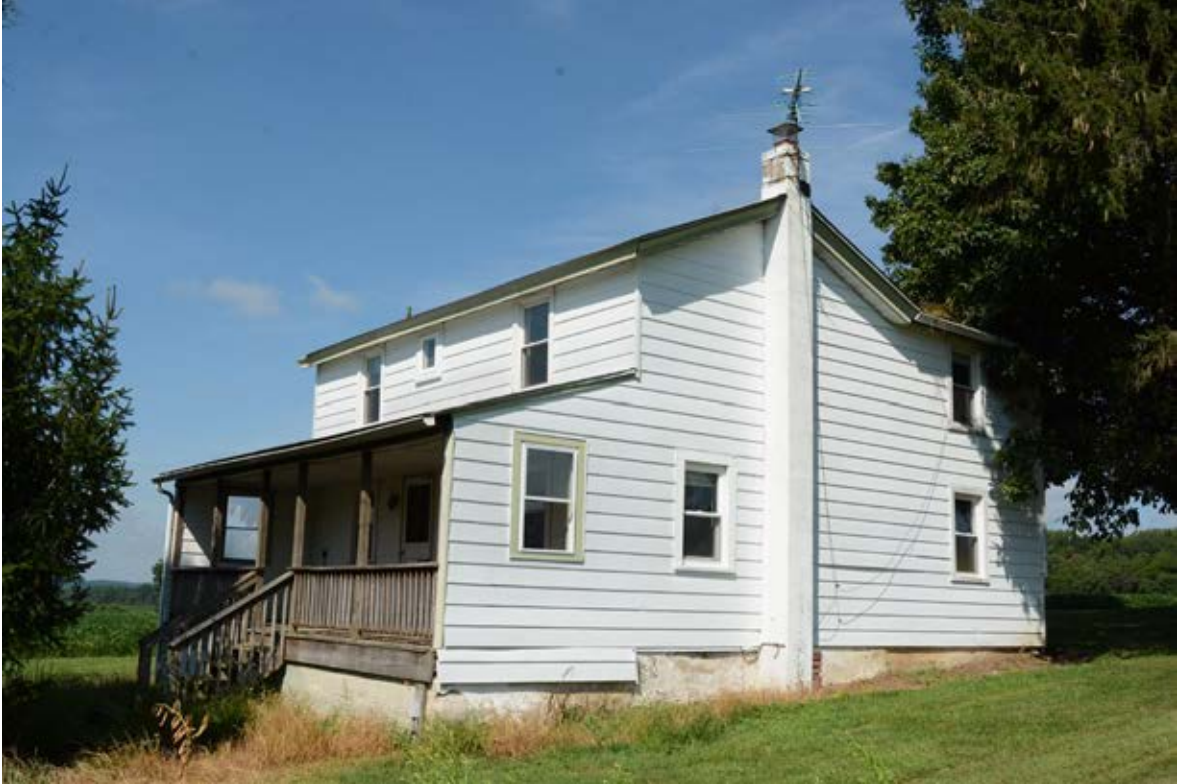
Photo 27

The **Michael Brennan house** is a two-part vernacular building in the eastern portion of Crebilly Farm (Photo 27), accessed by a long farm lane off Wilmington Pike and was determined not eligible for the NRHP (April 10, 1995 as “the McClure Property,” Key #103544). It is comprised of a two-story core with a two-story, one-bay ell. The two-story, four-bay frame main block faces south with overall dimensions of approximately 30 feet by 15 feet. Its end-gabled roof is clad with asphalt shingles and features a twentieth century block chimney centered on the east end. The walls and eaves are clad with aluminum siding. All windows are 1/1 replacement units; some original windows have been altered or sealed. The main elevation has two windows on the second floor, aligned with the two first floor windows; a reduced window on the second floor now lights a bathroom. The first floor has replacement doors in the two center bays, shaded by a full-length front porch supported by four simple columns connected by a railing. The end walls have a single 1/1 window: one on the first floor of the east end and the second floor of the west end. The one-story, one-bay frame rear addition (circa 1900) has a shallow-pitched, gabled roof clad with asphalt shingles. The walls are clad with aluminum siding, with a single rank of 1/1 replacement windows on each wall.

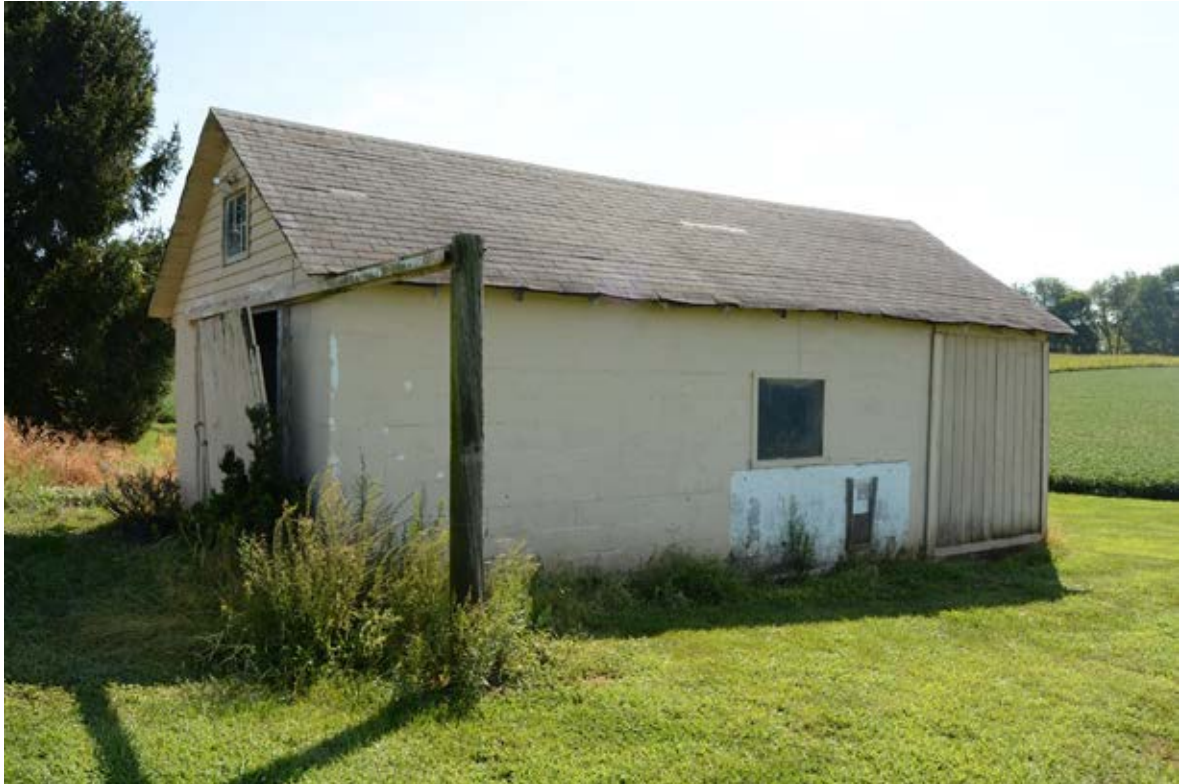
Photo 28

A **block outbuilding** is located southwest of the Michael Brennan House (Photo 28). The building measures approximately twelve feet square with a front-end-gabled orientation, constructed circa 1940. Its roof is clad with asphalt shingles and features exposed rafter tails on the side walls. The walls of the building are block except for the framed south end of the building. The north end has a large batten sliding door under a six-light window in the frame gable. The foundation is also block.

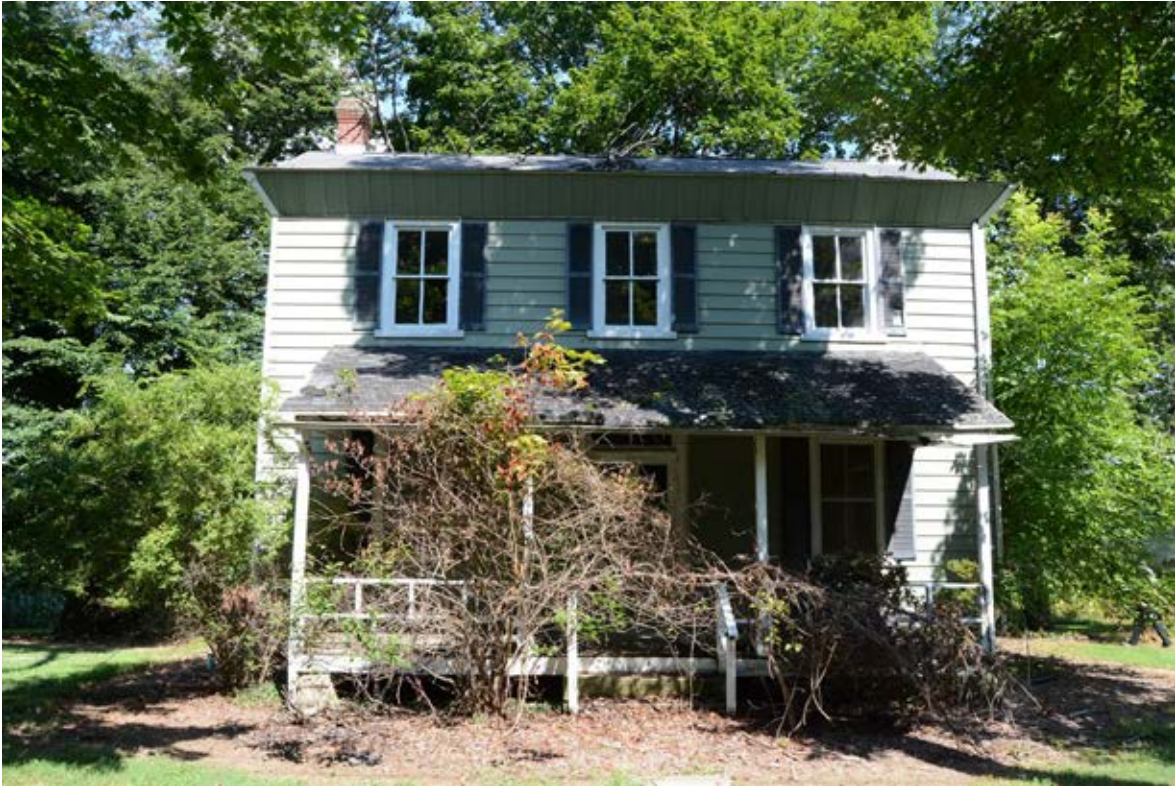
Photo 29

The **J.Q. Taylor tenant house** is a two-part Italianate style building (circa 1890) located at 201 West Street Road (Photo 29). The two-story, three-bay main block has a rear tee section. The building has been highly altered, including the installation of aluminum eaves and aluminum siding. The two-story, three-bay main block faces south onto Street Road and has approximate measurements of 25 feet by 15 feet. It has an end-gabled roof clad with asphalt shingles. A small chimney is located at each end of the ridge. The original

molded cornice and frame walls are aluminum-clad. Fenestration is symmetrical, with three bays on the main (south) elevation. The end walls feature a single off-center rank of windows. Windows are all 2/2 units with inoperable louvered shutters. Centered on the south elevation is the main entrance, consisting of a double door opening under a wide two-light transom. A one-story porch extends along most of the front of the main block; its asphalt-shingled roof is supported on four thin columns connected by a railing. The foundation is serpentine stone. The two-story, one-bay rear addition is centered on the rear of the main block. Its cladding consists of a gabled, asphalt-shingled roof and aluminum walls. Fenestration consists of one rank of 2/2 windows with inoperable louvered shutters on the east and west sides plus a six-light unit on the north wall and a two-light unit on the west wall. A narrow two-story utility stack addition is located on the north end and includes a basement door. An enclosed porch on the east elevation has a multi-light door and glazed walls.
