MEMORANDUM

Subject: 2020 NPDES MS4 Permit Support Services – Municipal Facilities Inventory Update and Inspection

MS4 – Municipal Facilities Inventory Update and Inspection

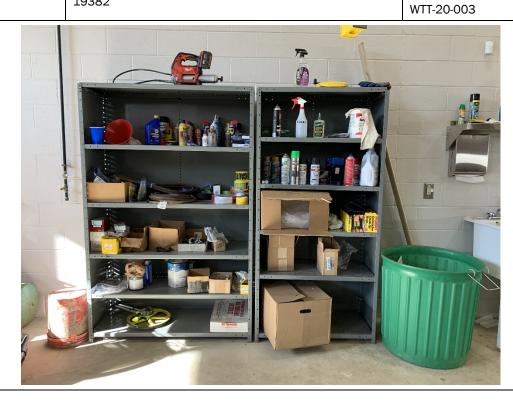
Photo No. Date: 3/5/20

Chemical supplies on a shelving unit.

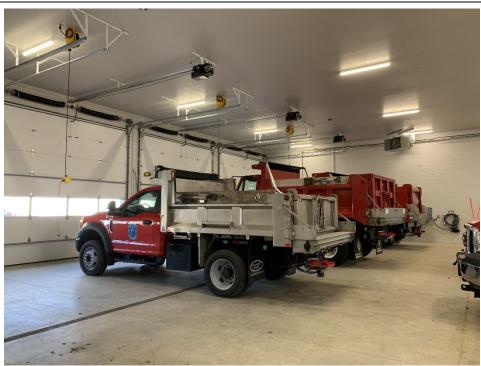
Photo No. Date: 2 3/5/20

Public Works trucks.

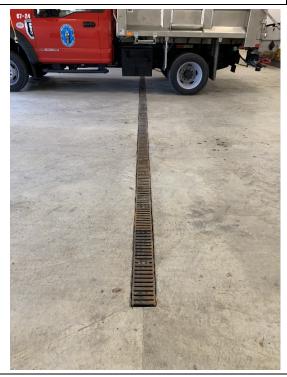
Photo No. Date: 3/5/20

Floor drain in the Public Works Garage.

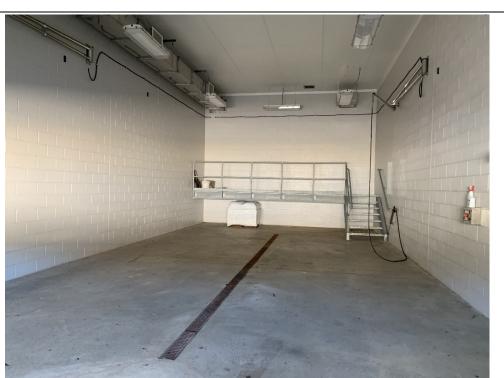
Photo No. Date: 3/5/20

There is a designated indoor car washing bay within the public works garage. The bay has a floor drain, which is also connected to the oil-water separator.

Wash bay for vehicles.

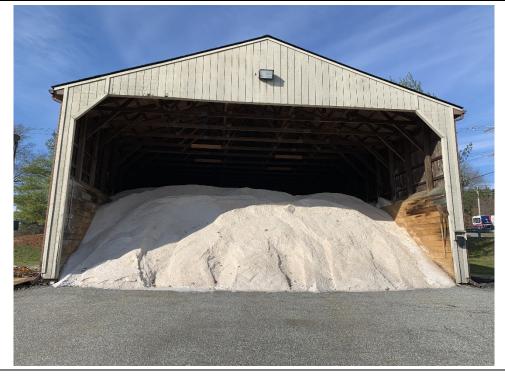
Photo No. 5

Road salt was properly contained within the storage shed and did not have any noticeable holes in the roof. No salt stains were observed outside of the storage shed.

Salt shed.

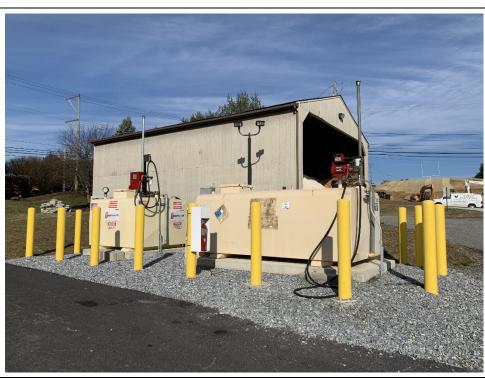
Photo No.

A fueling station is located at the public works complex. The fueling station consists of a 1,000-gallon diesel aboveground storage tank (AST) and 500-gallon gasoline AST and associated pumps on a concrete pad. The ASTs associated with the fueling station are steel, double-wall concrete encased for secondary containment with leak detection. No leaking or staining was observed surrounding the fueling station. The Township uses dry cleanup methods in the event of a spill.

Fueling tanks (1,000-gal diesel, 500-gal gasoline).

OBSERVATION	IMPORTANCE	RECOMMENDED ACTION
Spill clean-up using Oil-Dri was left on the floor.	Spill stains on the floor is an indication of poor spill response actions.	Perform spill response actions (dispose of Oil-Dri) as soon as the spill clean-up concludes to ensure minimal to no staining and to clear debris from the floor.
No BMPs were observed at the outdoor fueling station to minimize the potential for pollutant runoff if a spill were to occur while filling a vehicle.	Based on previous CEG experience, PA DEP has required a BMP to address potential pollutant runoff while filling a vehicle.	Consider utilizing one or more of the following BMPs to minimize the potential for pollutant runoff while filling vehicles: cover with a roof/overhang or place berms to prevent run-on to and runoff from the station.

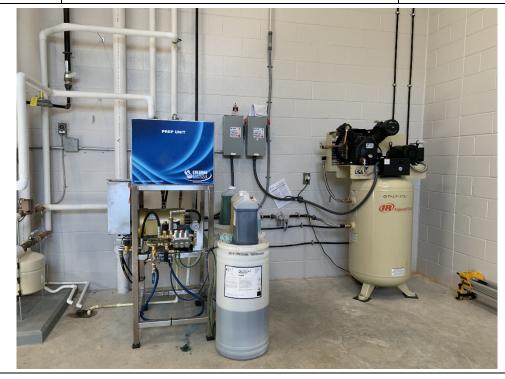
Photo No.

Inside the supply room where the wash bay chemicals are stored.

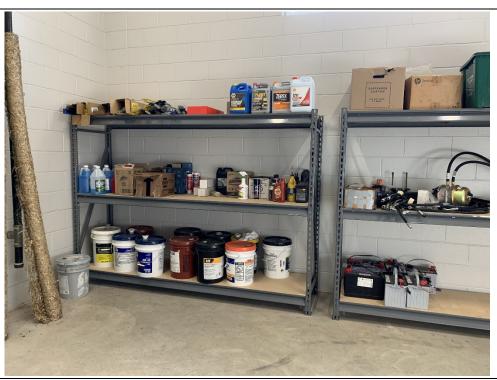
Photo No. 8 **Date:** 3/5/20

Shelving units with elevated chemicals in the supply room.

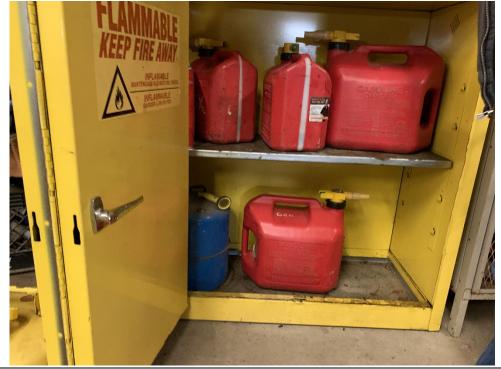
Photo No. Date: 3/5/20

Gasoline containers contained.

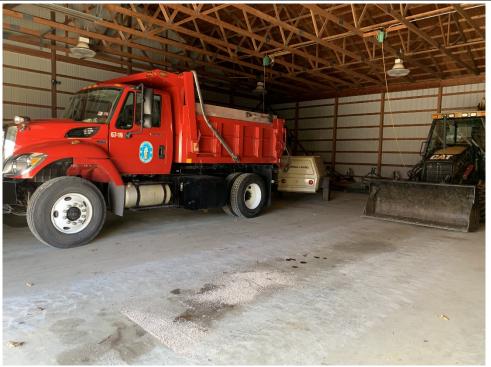
Photo No. Date: 3/5/20

Minor recommendations were documented for this facility. Oil-Dri was used to remediate a small spill and left in place on the garage floor. The outdoor fueling station did not have a best management practice (BMP) in place to minimize pollutant runoff if a spill were to occur while filling a vehicle. Recommended actions for these observations are noted below.

Spill cleaned up using Oil-Dri.

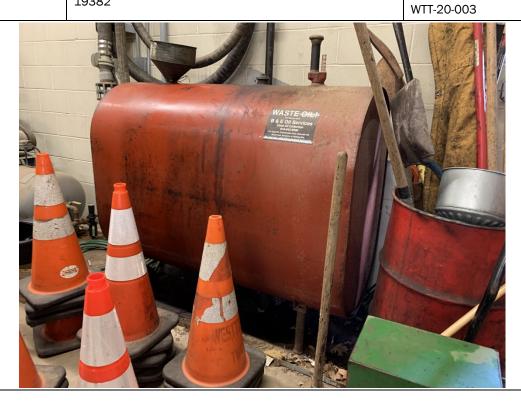
Photo No. 11 **Date:** 3/5/20

Waste oil tank.

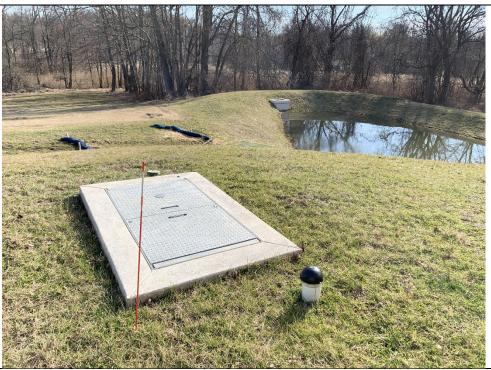
Photo No. 12 **Date:** 3/5/20

Oil-water separator and the stormwater basin adjacent to the Public Works building where all the floor and roof drains drain to.

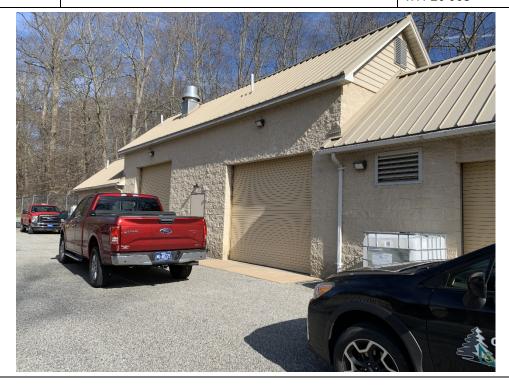
Photo No. Date: 3/5/20

Roof drains from the building discharge onto the pavement and into a stone infiltration bed.

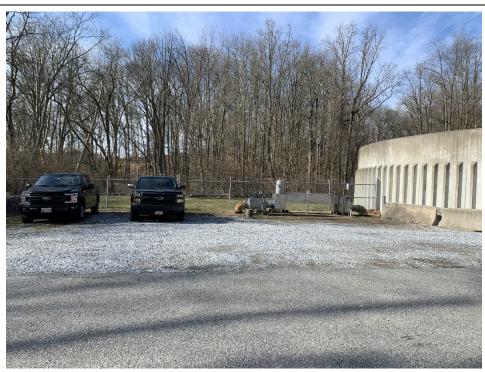
Photo No. Date: 3/5/20

Stone infiltration bed for stormwater runoff.

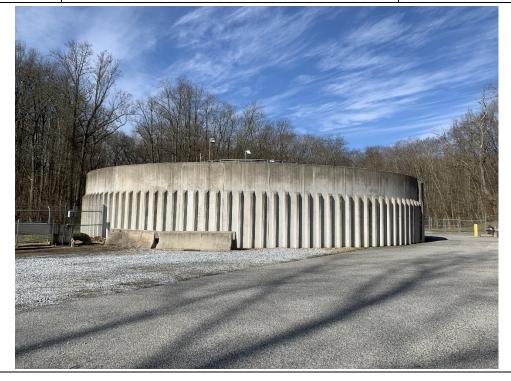
Photo No. 3 **Date:** 3/5/20

Treatment facility.

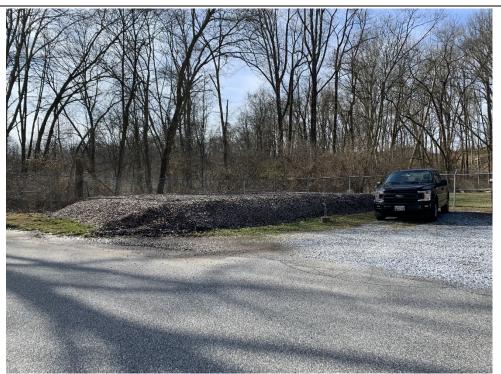
Photo No.

Bio-filter for odor control.

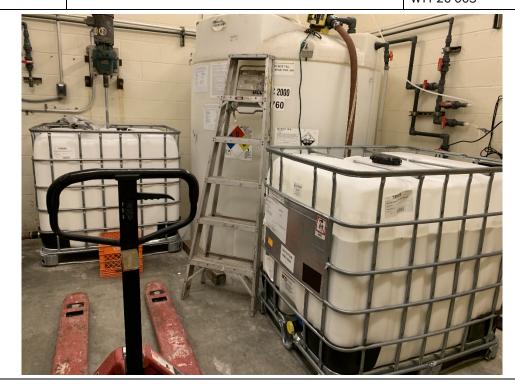
Photo No. Date: 3/5/20

Chemical storage on a pallet.

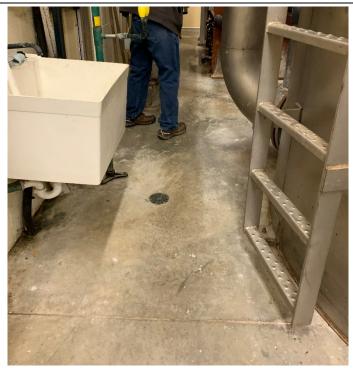
Photo No. Date: 3/5/20

Floor drain.

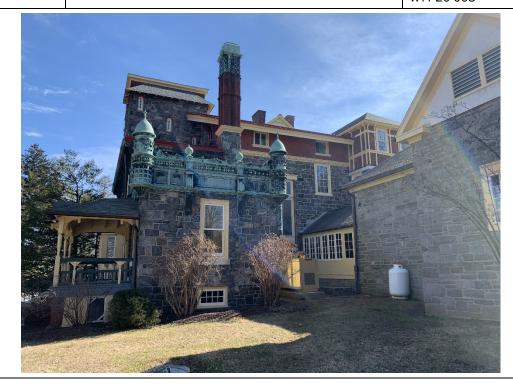
Photo No. Date: 3/5/20

The interior of the mansion was clear of clutter and did not display any potential for stormwater pollution. The roof drains from the mansion drain underground and discharge to an unknown location. For mapping purposes, it would be ideal to determine the system of this conveyance.

Side of the mansion where the roof drains lead into the ground.

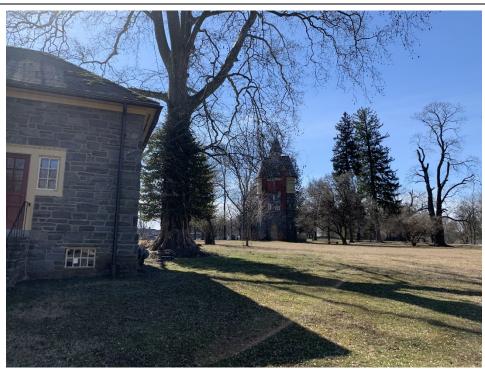
Photo No. Date: 2 3/5/20

Roof drains and water tower.

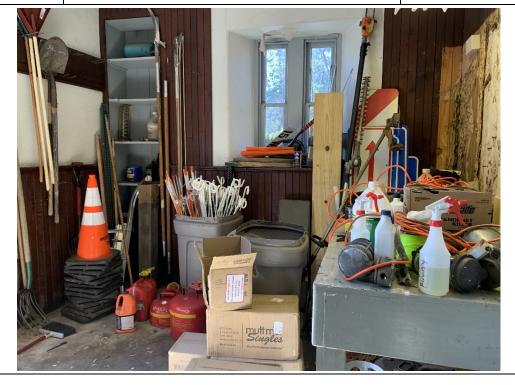
Photo No. Date: 3/5/20

In the storage garage, all chemicals and gasoline containers had proper containment within a section of the garage, which had no floor drains. There was no floor drain where the chemicals and gasoline are stored. There are also no vehicles stored at this location. There is a small floor drain in a separate room in the storage garage which discharges to an unknown location.

Inside the storage garage.

OBSERVATION	IMPORTANCE	RECOMMENDED ACTION
	Being able to determine the stormwater system will allow timely and proper remediation in the event of a spill, though the potential for pollution from this floor drain is currently low as there are no chemicals, fuel, etc. stored in the immediate vicinity.	discharges by conducting a dye test or locating building plans; or plug the floor drain with a permanent or temporarily option if the use of this

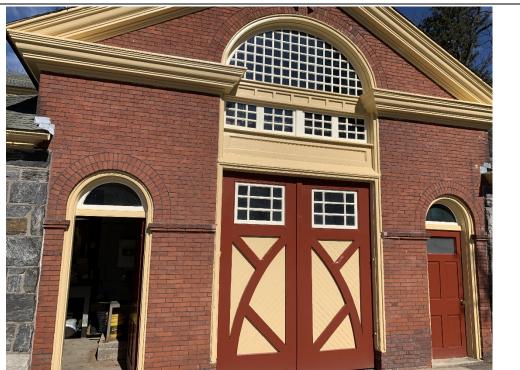
Photo No.

Storage garage.

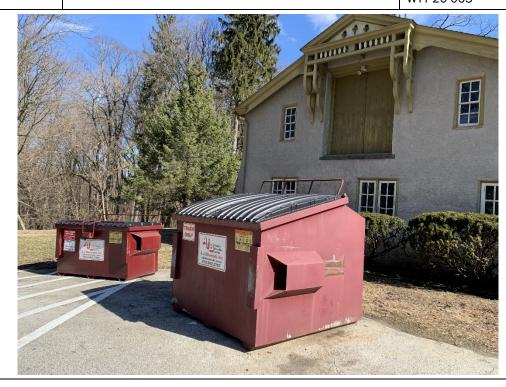
Photo No. Date: 3/5/20

2 dumpsters.
